Control of Slab Curling in Rigid Pavements at the FAA National Airport Pavement Test Facility

Abstract

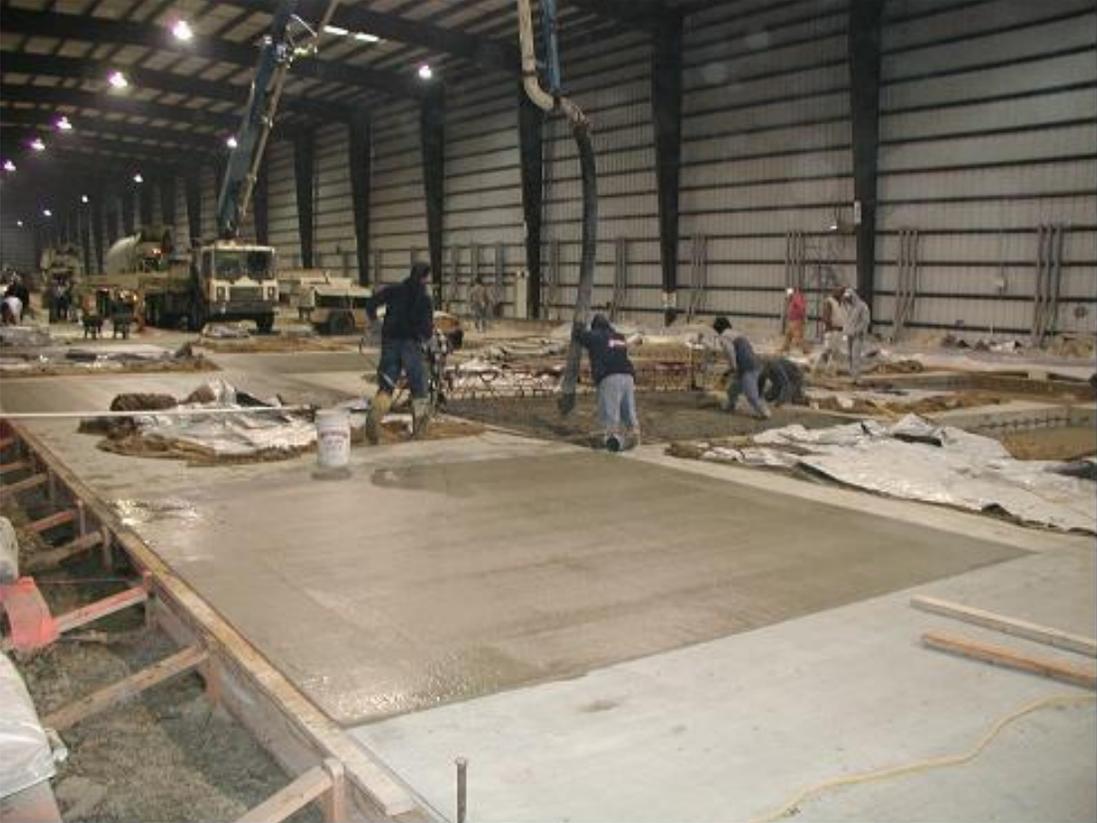
Each test item was placed on two different days about two weeks apart. The slabs were placed in a “checkerboard” pattern in order to accommodate the installation of steel dowels connecting the sides of adjacent slabs. The need for supporting chairs was eliminated. Figure 2 shows the placement of MRG on the second day. Concrete placement was performed between January 7 and March 2, 2004. Reference [3] provides more detailed information on the construction and trafficking of the CC-2 test items.

FIGURE 2 Second Placement of Concrete in MRG.

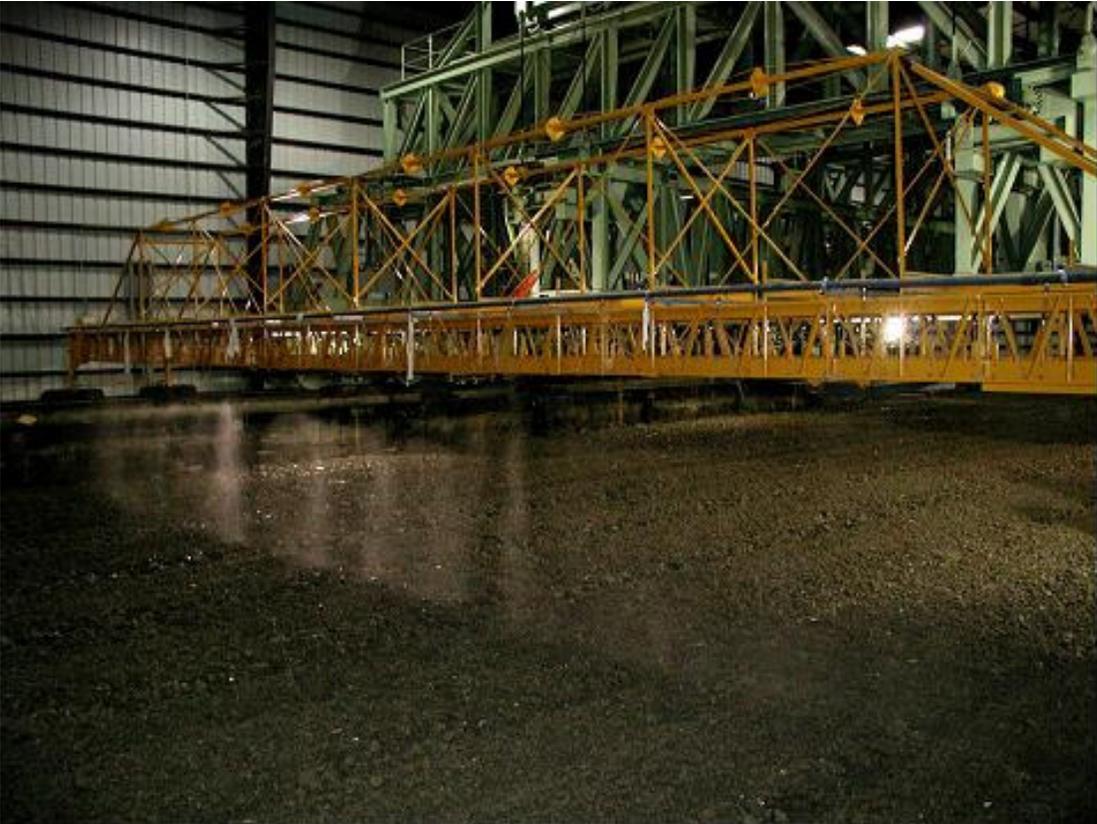
The addition of water to the burlap was needed three times during the 28 day curing cycle based on visual observation of the condition of wetness. Visual observations indicated that there was a need for watering prior to anything critical being noted in the readings provided by the vertical displacement transducers. Plastic sheets and thermal blankets were temporarily removed from above the burlap. Watering was accomplished using a mobile bridge. The bridge spanned the width of the pavements and rode on the rails of the traffic test vehicle. It was propelled by the test vehicle. The bridge was equipped with a row of nozzles producing what appeared to be a line of rainfall. Figure 3 shows the mobile bridge in operation while conditioning a lift of clay subgrade during an earlier part of the construction. The mobile bridge is now self-propelled.

FIGURE 3 Watering Subgrade Lift.

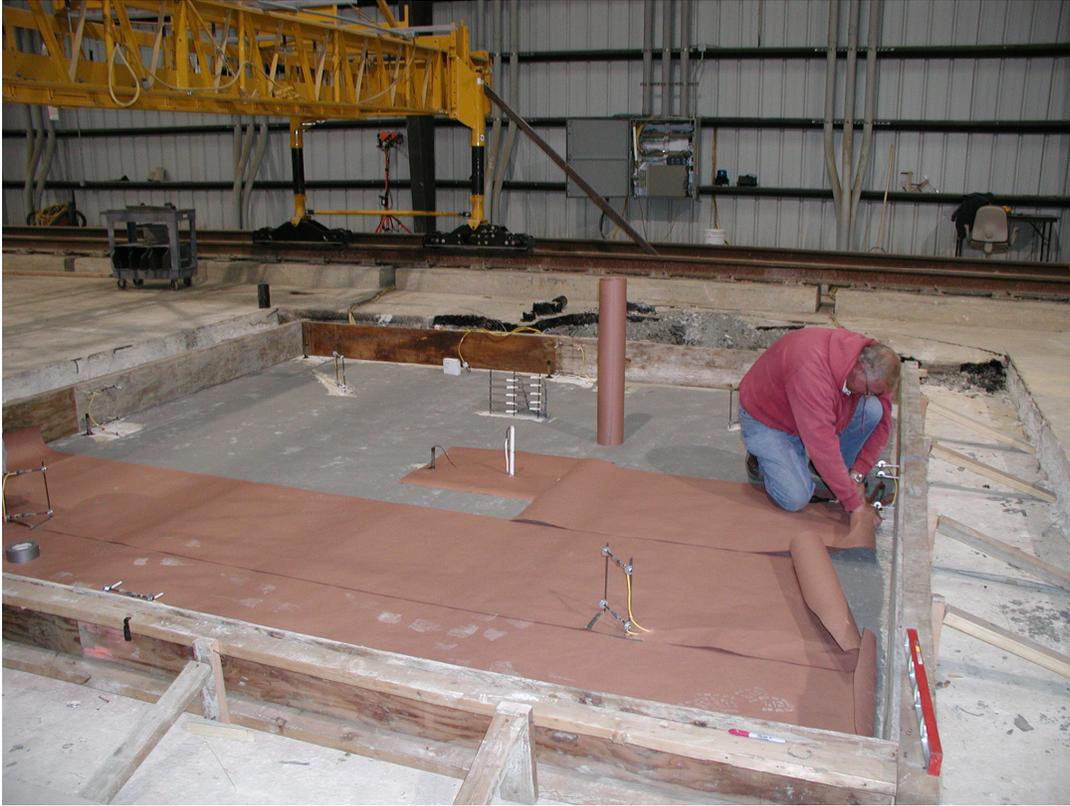
The twin slabs each had the same dimensions as the original inside slab. The cementitious mix did not incorporate flyash. Comparison of the behavior of the inside slab with the original would indicate whether flyash had any significant effect on curling. Instrumentation of the twin slabs was similar to that of the original inside slab. Figure 5 shows the instrumentation for the new inside slab. Construction paper is being set in place serving as the bond breaker between the slab and the base. Figure 6 shows the concrete placement. Attention focused on hand packing the concrete around the instruments.

FIGURE 5 Instrumentation and Bond Breaker for Inside Slab.

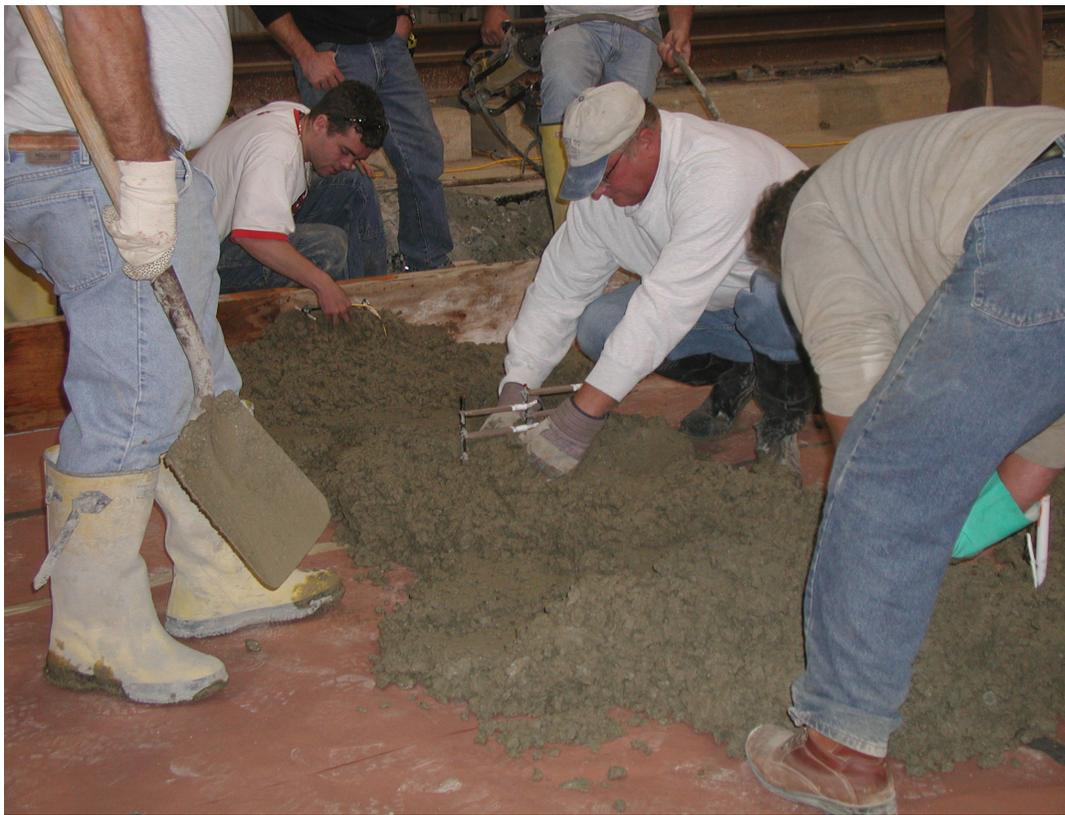
FIGURE 6 Concrete Placement for Inside Slab.

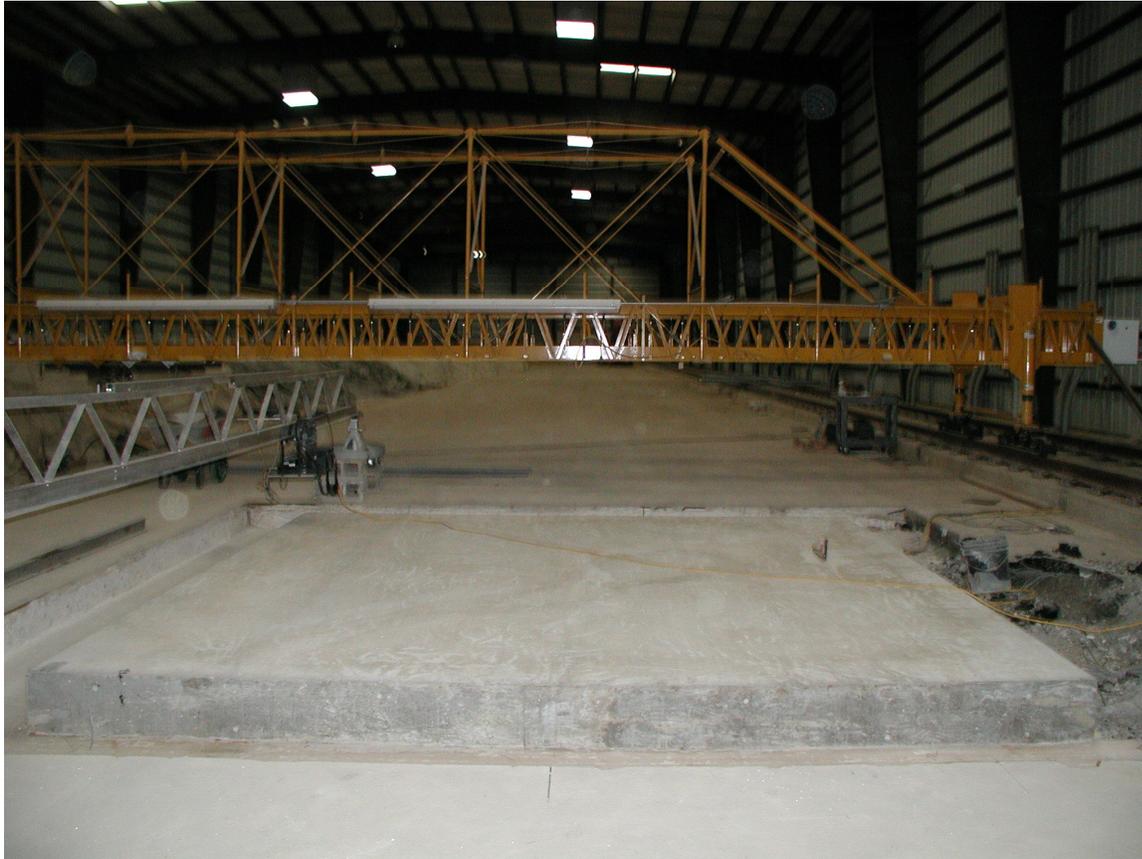
The twin slabs were placed on an econocrete stabilized base which rested on a granular subbase supported by high strength subgrade. These conditions existed within the NAPTF, but had to be duplicated outside. A temporary canopy had to be erected in order to protect the construction of the outside slab from inclement weather. The twin slabs were placed on October 13, 2004. Wet curing procedures were similar to those used for the original inside slab. Curing lasted for 68 days. The slabs were allowed to dry starting on December 20, 2004. Figures 7 and 8 show the cured slabs in place.

FIGURE 7 Inside Slab (Mobile Bridge in Background).

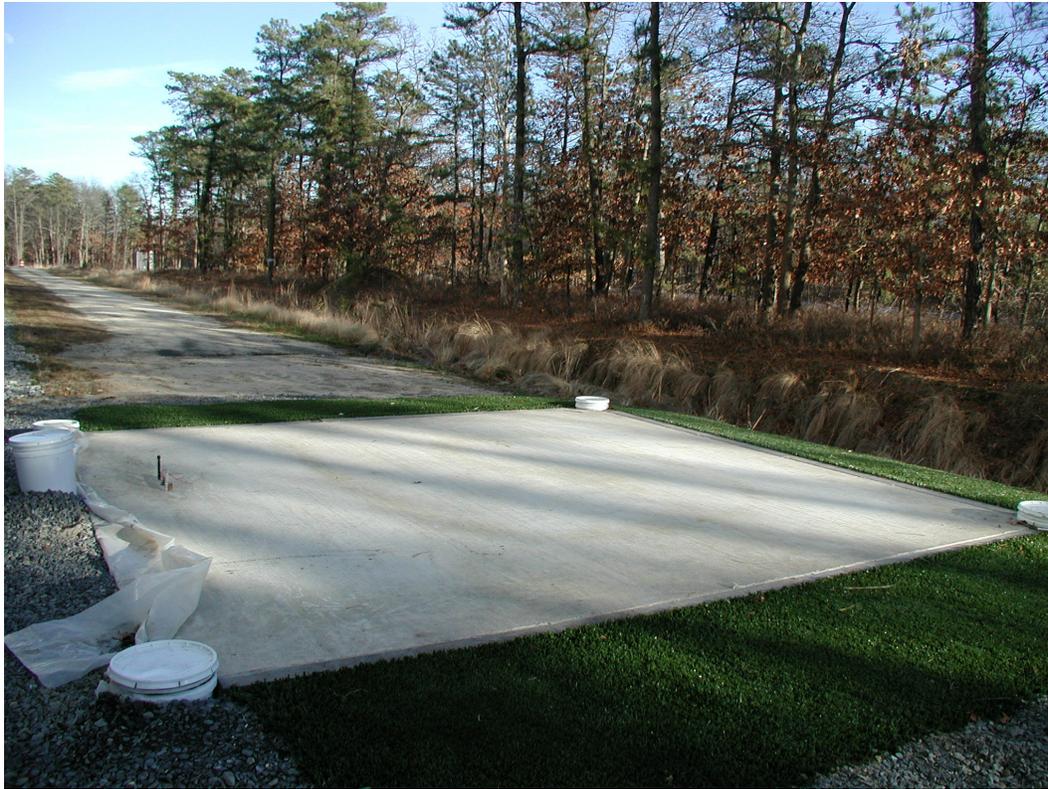
FIGURE 8 Outside Slab.
